[Home](#) > [How to Preserve](#) > Preservation Briefs

Preservation Briefs provide guidance on **preserving, rehabilitating, and restoring** historic buildings. These NPS Publications help historic building owners recognize and resolve common problems prior to work. The briefs are especially useful to **Historic Preservation Tax Incentives Program** applicants because they recommend methods and approaches for rehabilitating historic buildings that are consistent with their historic character.

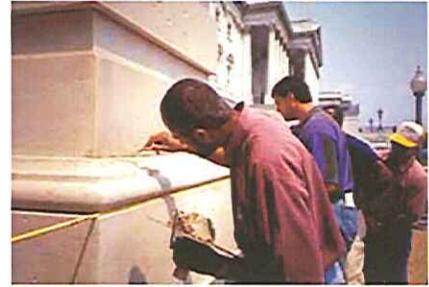
Masons practice using lime putty mortar to repair historic marble. Photo: NPS files.

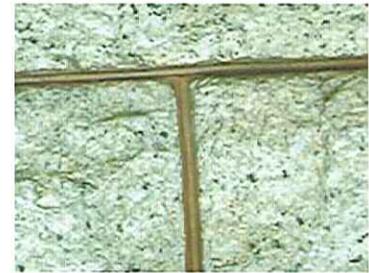
This late 19th century granite has recently been repointed with the joint profile and mortar color carefully matched to the original. Photo: NPS files.

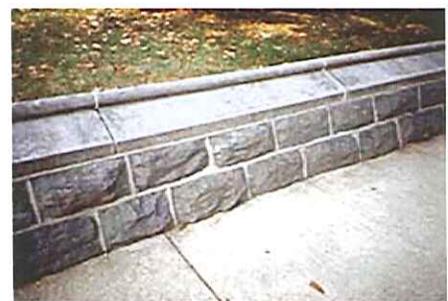
Caulking was inappropriately used here in place of mortar on the top of the wall. As a result, it has not been durable. Photo: NPS files.

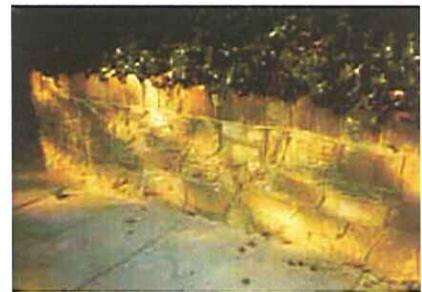
When repairing this stone wall, the mason matched the raised profile of the original tuckpointing. Photo: NPS files.

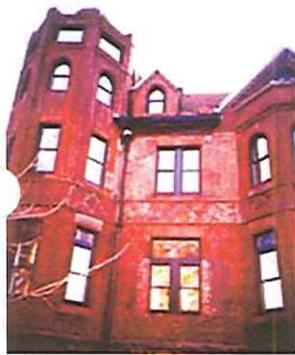
Unskilled repointing has negatively impacted the character of this late-19th century building.
Photo: NPS files.

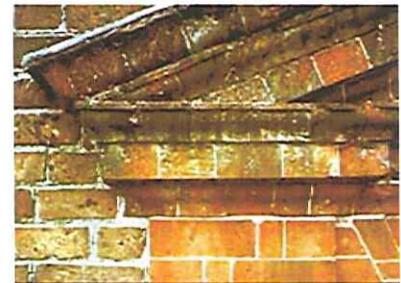
This 18th century pediment and surrounding wall exhibit distinctively different mortar joints. Photo: NPS files.

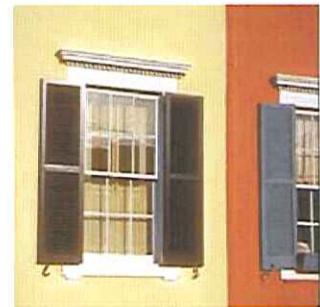
Historic six-over-six windows--preserved. Photo: NPS files.

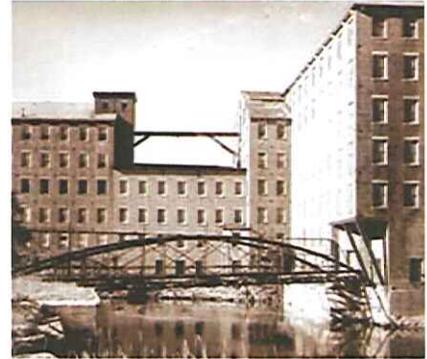
Windows are frequently important visual focal points, especially on simple facades such as this mill building. Replacement of the multi-pane windows with larger panes could dramatically alter the appearance of the building. Photo: NPS files.

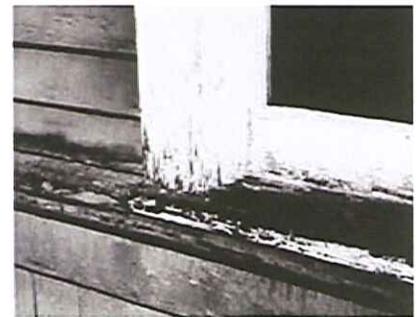
Deterioration of poorly maintained windows usually begins on horizontal surfaces and at joints, where water can collect and saturate the wood. Photo: NPS files.

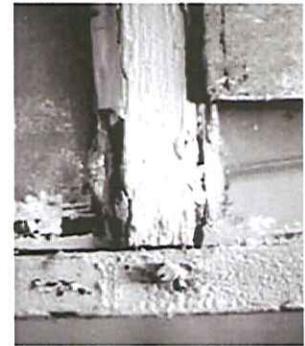
This historic double-hung window has many layers of paint, some cracked and missing putty, slight separation at the joints, broken sash cords, and one cracked pane. Photo: NPS files.

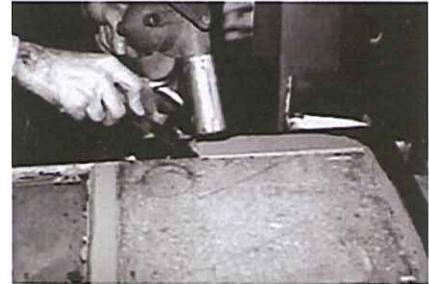
Sash can be removed and repaired in a convenient work area. Paint is being removed from this sash with a hot air gun. Photo: NPS files.

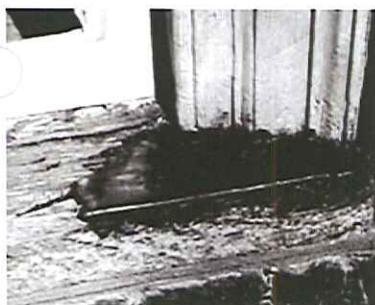
This illustrates a two-part epoxy patching compound used to fill the surface of a weathered sill and rebuild the missing edge. When the epoxy cures, it can be sanded smooth and painted to achieve a durable and waterproof repair. Photo: NPS files.

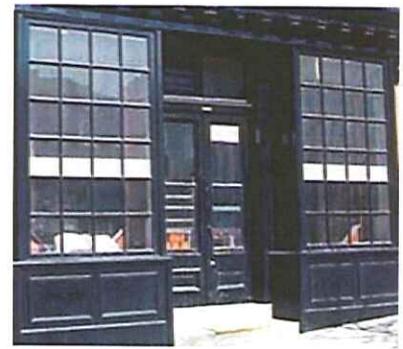
This cast iron storefront from the late 19th century has been well maintained over the years. Photo: NPS files.

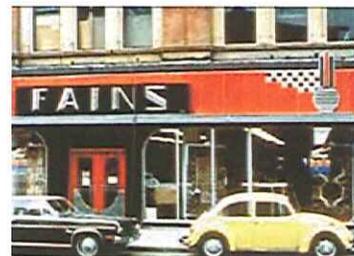
This 1930s Moderne storefront has gained significance over time and should be preserved. Photo: NPS files.

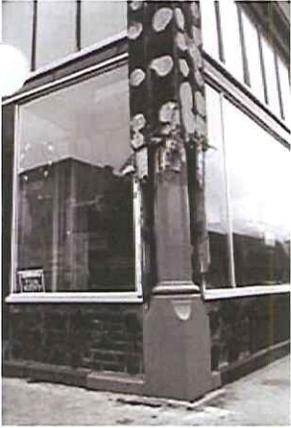
Storefronts of the 1940s, 50s, and 60s were frequently installed by attaching studs or a metal grid over an early front and applying new covering materials. Photo: Bob Dunn.

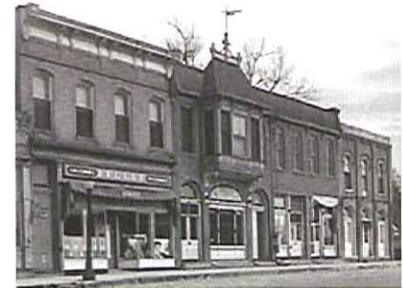
By evaluating the components of a storefront as well as their existing condition, a successful rehabilitation is more likely. Photo: HABS collection, NPS.

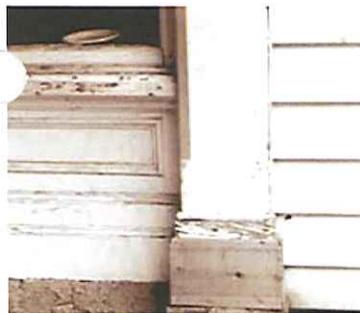
Rather than replace an entire wooden storefront, a new wooden component can be pieced-in, as seen in this column base. Photo: NPS files.

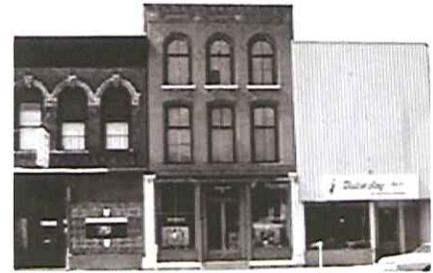
This photograph shows the impact of preserving historic storefronts. The one on the right has been totally obscured by a "modern" front added in the 1950s. Photo: NPS files.

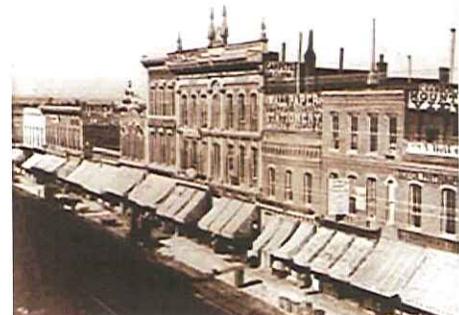
Try to locate old photographs or prints to determine what alterations have been made to the storefront and when they were undertaken. Awnings were common elements of storefronts at the turn of the century. Photo: NPS files.

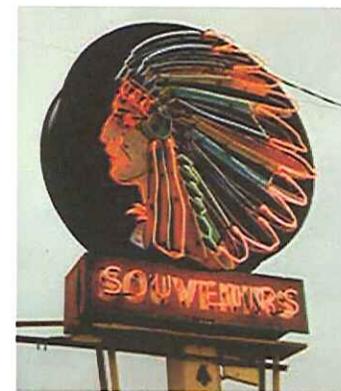
Neon first appeared in signs in the 1920s, and reached its height of popularity in the 1940s. Photo: Peter Phillips.

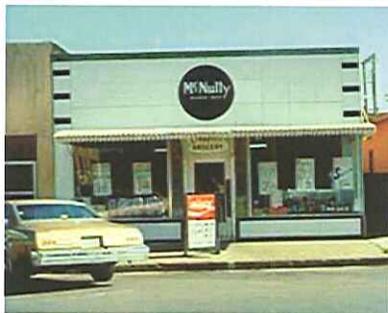
In the 1930s and 1940s, signs built into storefronts became popular. This example is from Guthrie, Oklahoma. Photo: NPS files.

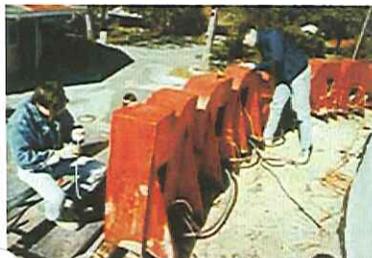
Workers prepare the "metal cans" from a sign for re-mounting. Photo: Larry Kanter.

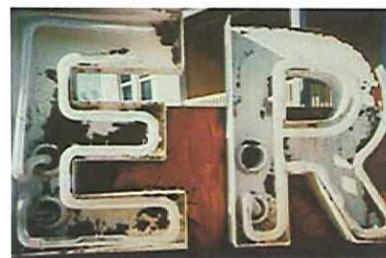
These tubes in this amusement park's sign were broken and the surrounding "metal cans" needed work also. See below. Photo: Stan Fowler.

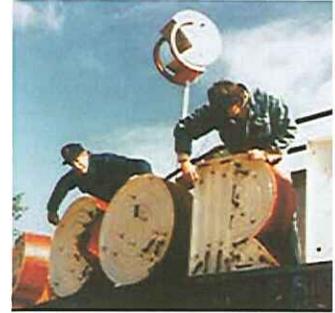
Neon fabricators are installing the new tubing in the repaired and remounted cans. Photo: Larry Kanter.

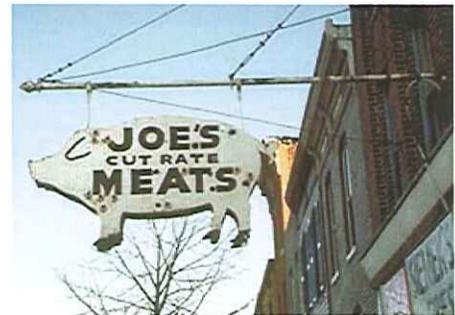
This hanging pig is delightful, even without its neon. Holes show where tubing was attached. It has been a local landmark in Baltimore's Fells Point neighborhood for over 60 years. Photo: NPS files.

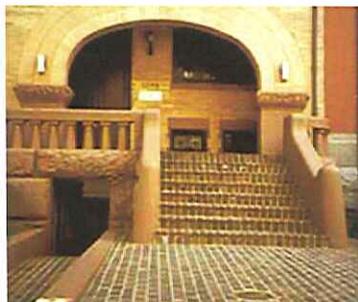
A significant entrance may be difficult to modify. Although a special challenge, sensitive changes can almost always be made to provide access while preserving

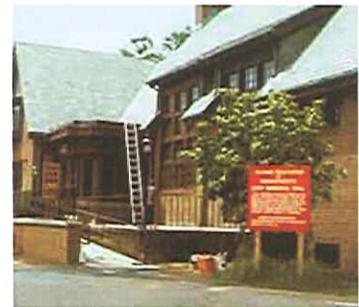
This accessibility ramp is compatible with the historic building in scale and materials. Photo: William Smith.

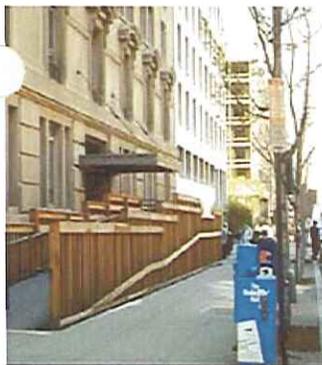
The ramp's scale and materials are inconsistent with the historic character of the building. Photo: NPS files.

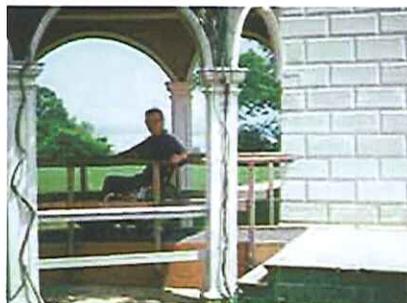
The significant building site is now accessible to people with disabilities (note steps in front of ramp). Photo: NPS files.

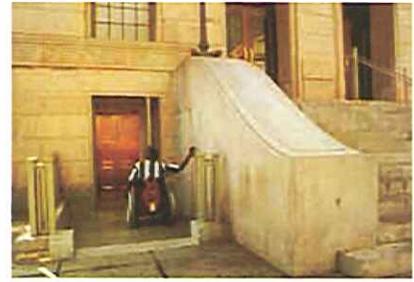
A new elevator entrance was provided next to the stairs to provide universal access to the services inside. Photo: Courtesy, GSA.

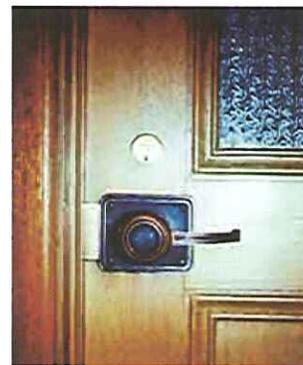
This door handle has been retrofitted to meet ADA requirements. Photo: NPS files.

Historic door knobs and other hardware may be difficult to grip and turn. In recent years, lever-handles have been developed to replace door knobs. Other lever-handle devices can be added to existing hardware. If it is not possible or appropriate to retrofit existing door knobs, doors can be left open during operating hours (unless doing so would violate life safety codes), and power-assisted door openers can be installed. It may only be necessary to retrofit specific doorknobs to create an accessible path of travel and accessible restrooms.

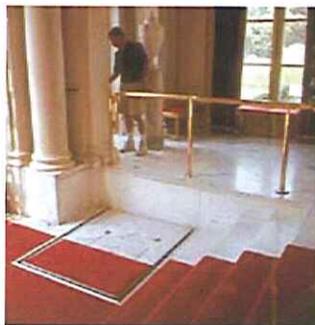
A retractable lift for this historic building foyer was created using "like" materials. Photo: NPS files.

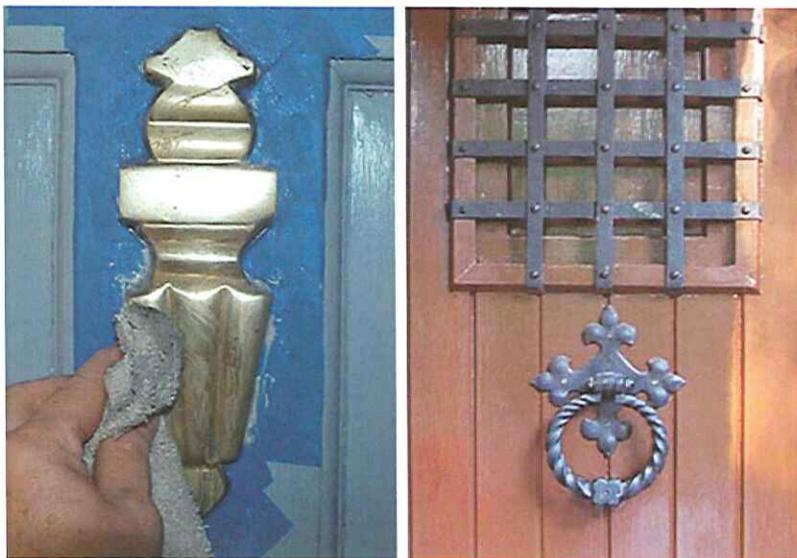
Figure 1. Maintenance involves selecting the proper treatment and protecting adjacent surfaces. Using painter's tape to mask around a brass doorknocker protects the painted door surface from damage when polishing with chemical compounds. On the other hand, hardware with a patinated finish was not intended to be polished and should simply be cleaned with a damp cloth.

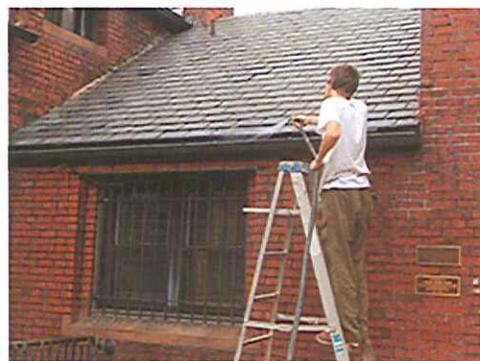
Figure 3. Keeping gutters clean of debris can be one of the most important cyclical maintenance activities. On this small one-story addition, a garden hose is being used to flush out the trough to ensure that the gutter and downspouts are unobstructed. Gutters on most small and medium size buildings can be reached with an extension ladder and a garden hose. Photo: Bryan Blundell.

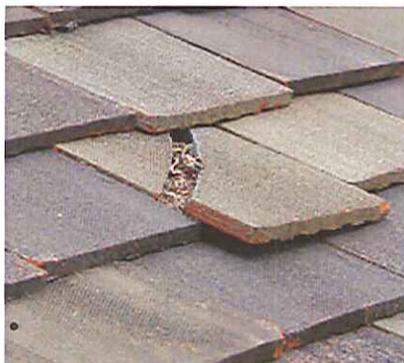
Figure 4. Damage to roofs often requires immediate attention. As a temporary measure, this damaged roof tile could be replaced with a brown aluminum sheet wedged between the existing tiles. Photo: Chad Randl.

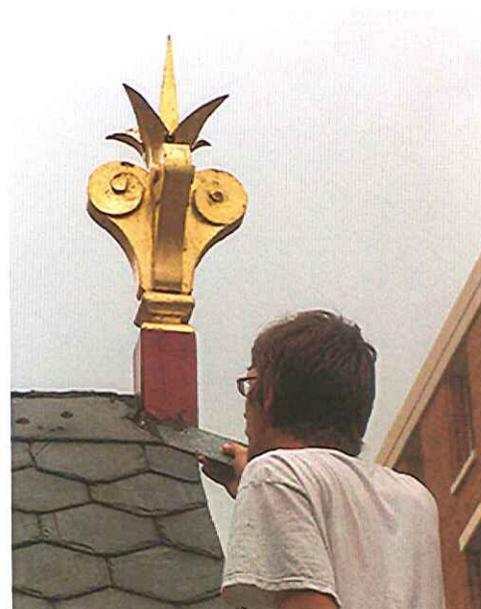
Figure 5. The use of a sealant to close an exposed joint is not always an effective long-term solution. Where this decorative wood element connects to the slate roof, the sealant has failed within a short time and a proper metal

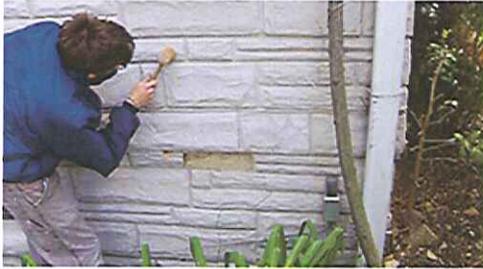
Figure 6. Stucco applied to an exterior wall or foundation was intended to function as a watertight surface. Unless maintained, rainwater will penetrate open joints and cracks that may occur over time. A spalled section of stucco indicates some damage has occurred and a wooden mallet is being used to tap the surface to determine whether the immediate stucco has lost adhesion. Photo: Bryan Blundell.

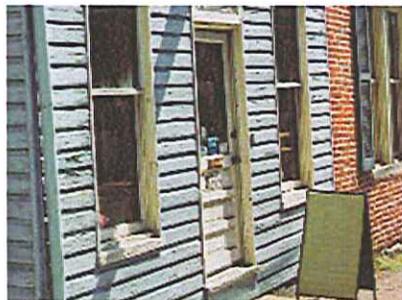
Figure 8. The paint on the siding of this south-facing wall needs to be scraped, sanded, primed and repainted. Postponing such work will lead to further paint failure, require greater preparatory costs, and could even result in the need to replace some siding. Photo: Charles Fisher.

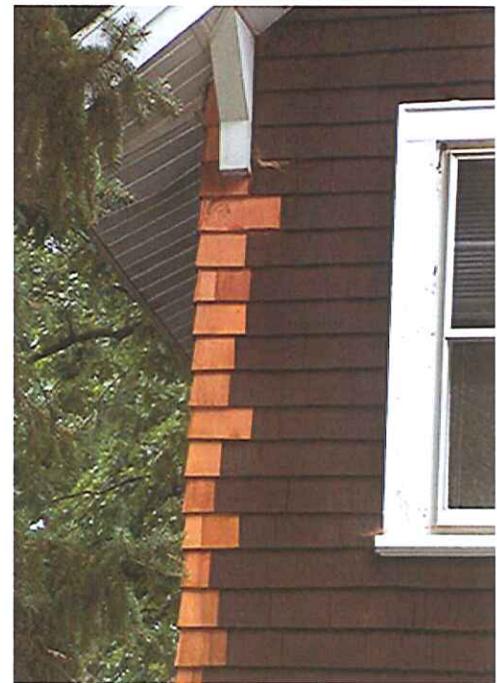
Figure 7. One of the advantages of wood shingles as a wall covering is that individual shingles that are damaged can easily be replaced. On this highly exposed corner, worn shingles have been selectively replaced to help safeguard against water damage. The new shingles will be stained to match the existing shingles.

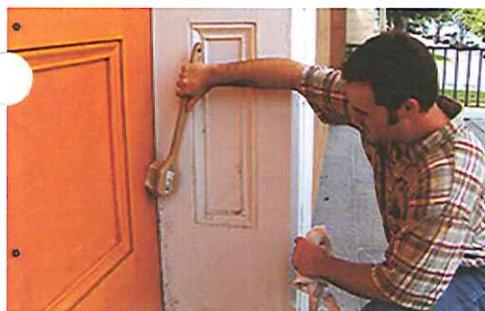
Figure 9. To help extend a repainting cycle, dirt and spider webs should be removed before permanent staining occurs. In this case, a natural bristle brush and a soft damp cloth are being used to remove insect debris and refresh the surface appearance.

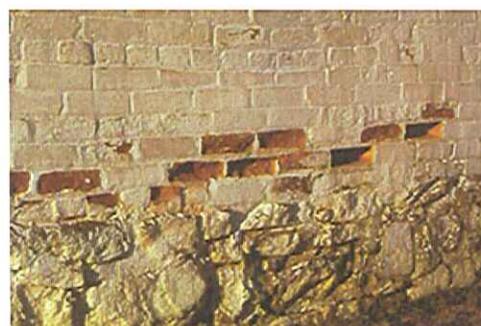
Figure 10. Repointing of masonry should usually be approached as repair rather than maintenance work in part because of the need for a skilled mason familiar with historic mortar. In this case, a moisture condition was not corrected and the use of a waterproof coating and off-the-shelf Portland cement mortar trapped water and resulted in further damage to these 19th century bricks. Photo: NPS files

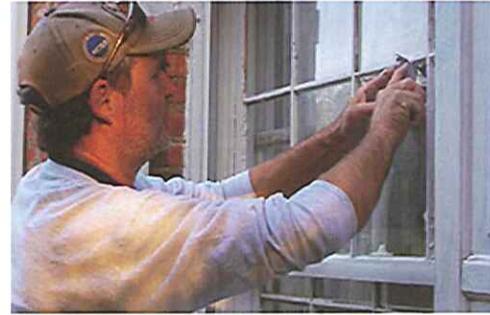
Figure 11. Glazing putty should be maintained in sound condition to prevent unwanted air infiltration and water damage. New glazing putty should be pulled tight to the glass and edge of the wood, creating a clean bevel that matches the historic glazing

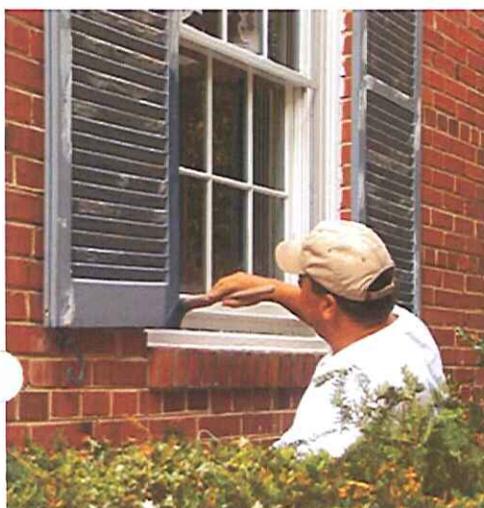
Figure 12. Good surface preparation is essential for long lasting paint. Scraping loose paint, filling nail holes and cracks, sanding, and wiping with a damp cloth prior to repainting are all important steps whether touching up small areas or repainting an entire feature. Always use a manufacturer's best quality paint. Windows and shutters may need repainting every five to seven years, depending on exposure and climate.

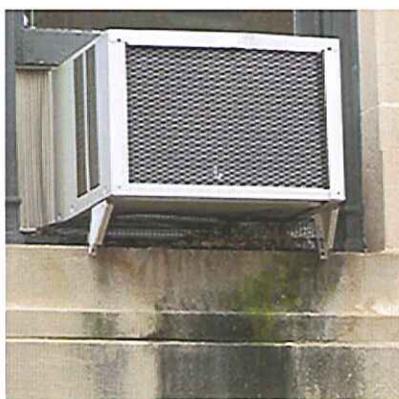
Figure 13. Window air conditioning units can cause damage to surfaces below when condensation drips in an uncontrolled manner. Drip extension tubes can sometimes be added to direct the discharge.

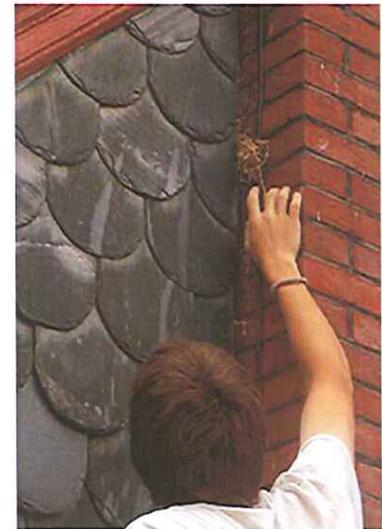
Figure 14. When inspecting connections between projections and the main building, look for areas where birds, bees and pests may enter or nest. Birds have been nesting in this porch roof and the area is being cleaned of their debris. Where an opening exists, it may be necessary to cover it with a trim piece, screening, or sealant. Photo: Bryan Blundell

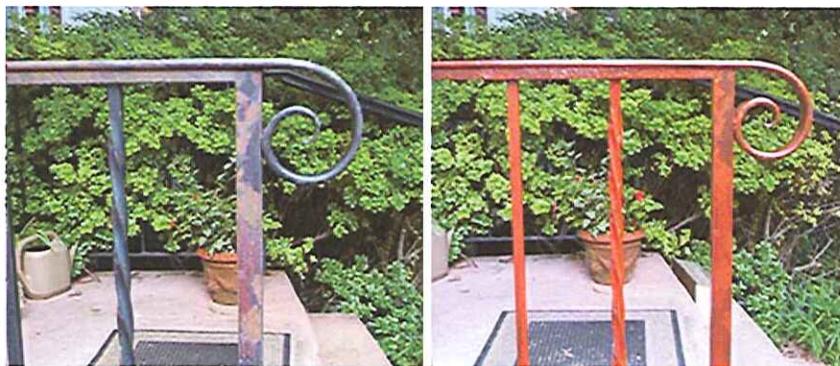
Figure 15. Metal projecting elements on a building, such as sign armatures and railings, are easily subject to rust and decay. Proper surface preparation to remove rust is essential. Special metal primers and topcoats should be use

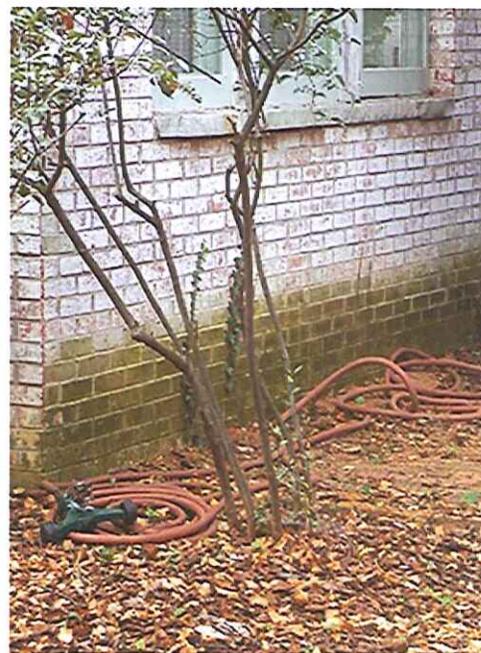
Figure 16. This chronically wet area has a mildew bloom brought on by heat generated from the air-conditioning condenser unit. The dampness could be caused by a clogged roof gutter, improper grading, or a leaking hose bibb.

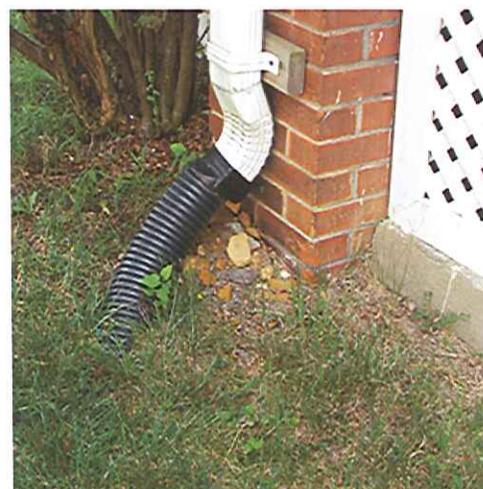
Figure 17. Extending downspouts at their base is one of the basic steps to reduce dampness in basements, crawl spaces and around foundations. Extensions should be buried, if possible, for aesthetics, ease of lawn care, and to avoid creating a tripping hazard. Photo: NPS files.
