Guidelines for Improving Energy Efficiency in Historic Buildings

Historic Preservation Guidelines for Energy Efficiency and Sustainable Practices

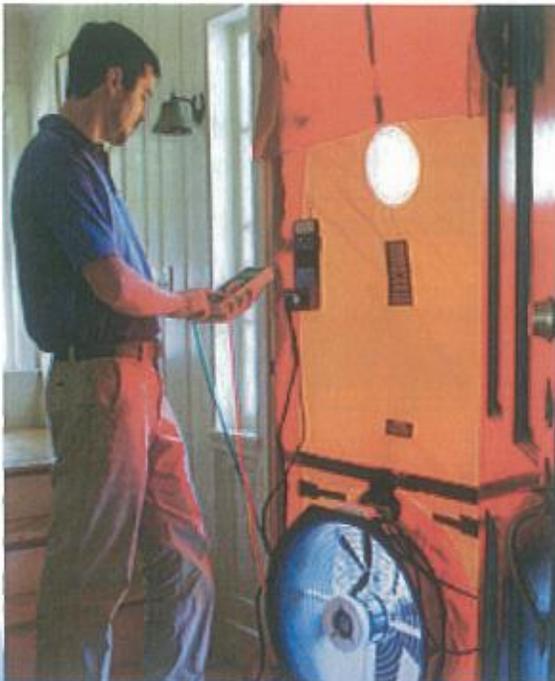
Figure 1
*Historic Building
Energy Audit*

Such measures include the addition of interior attic insulation, weatherstripping historic wooden storm windows, and re-glazing several of the original windows.

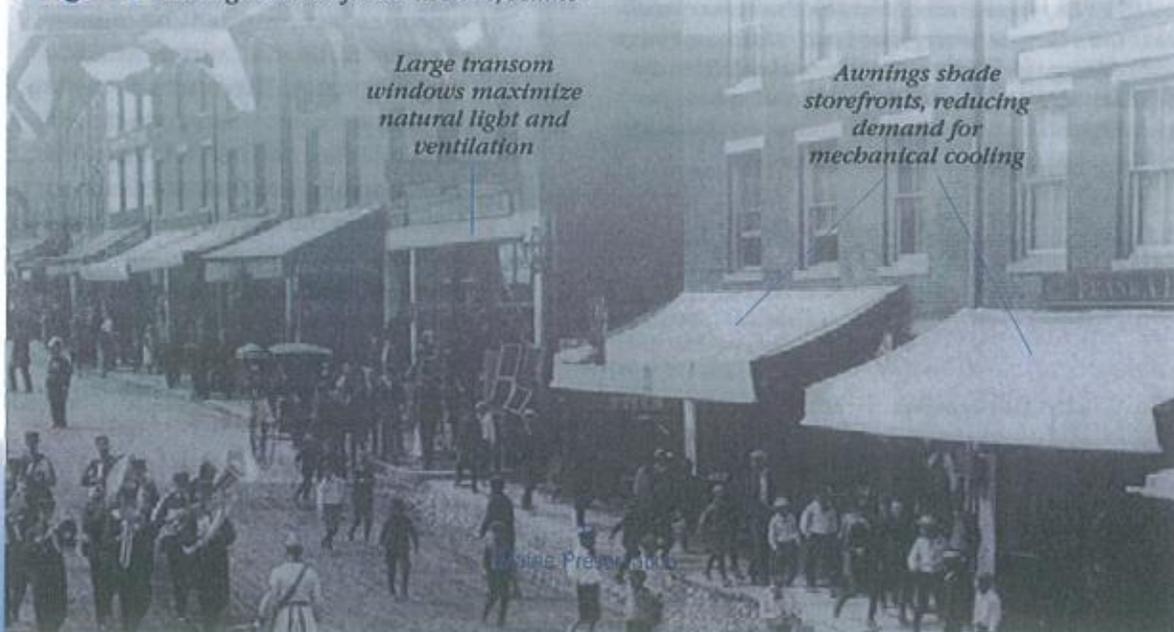
Figure 2 Awnings on storefronts in Bath, Maine

- *Avoid:* Removal of historic features that improve energy efficiency.
 - *Example:* Awnings, as seen in Figure 2, historically were used to provide shade and keep a building cooler in the summer. If awnings were in place historically, replace them or repair existing awnings to working order.

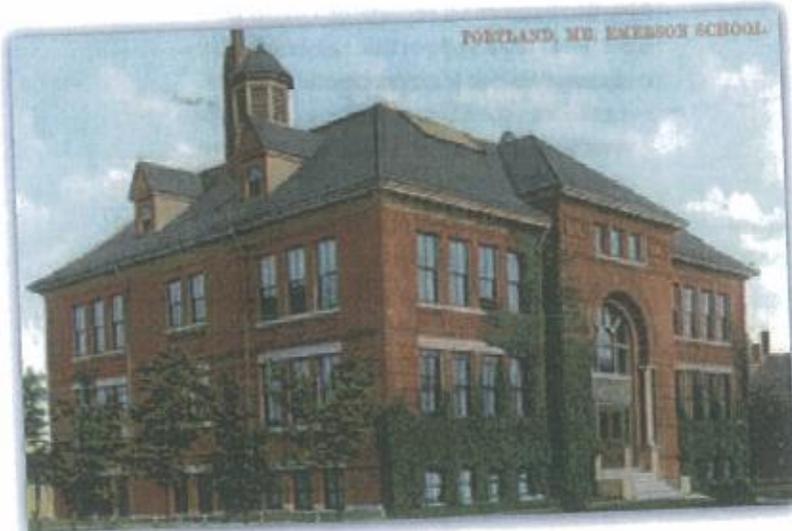
Figure 3 *The Emerson School in Portland was built in 1899. The former school has thick masonry walls that store thermal energy and each classroom has a wall of large windows to provide natural light and ventilation. Note, too, the dormers and cupola for ventilation. The circlehead window above the entry and the skylight provide natural lighting.*

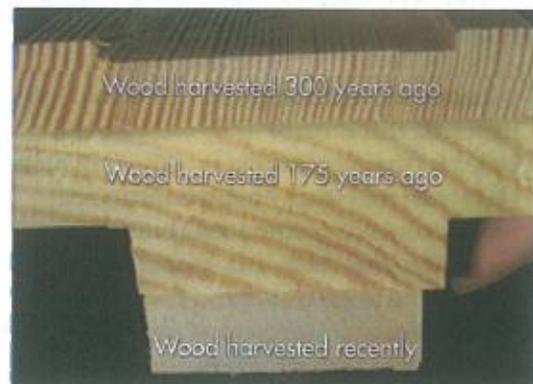
Old Growth Wood—In the photo above, the top board is in the ballpark of 300 years old with up to 30 growth rings per inch. The second board is 175 years old with 10 growth rings per inch. The bottom board is current lumber sold at a major home improvement supplier with 6 growth rings per inch. (The older wood was salvaged from demolished buildings.)

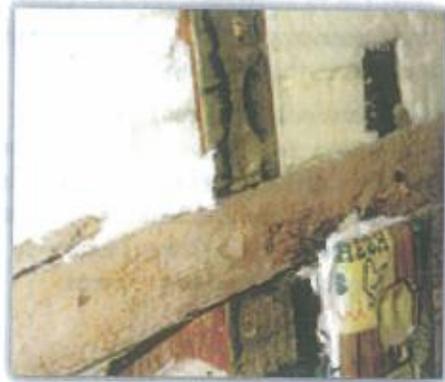
Figure 5
Urea Formaldehyde Foam Insulation

- o **Example:** Urea Formaldehyde Foam Insulation (UFFI), seen in Figure 5, was an insulation retrofit product used in the

1970's. It was later banned in Canada and the United States after elevated levels of formaldehyde (a known carcinogen) were found in a small number of homes. Not only was it dangerous to have in the walls, but it was also a hazard to remove. Beyond its formaldehyde content, the insulation did not allow for inspection or upgrading of various wall systems, allowing potentially dangerous structural conditions to go unnoticed.

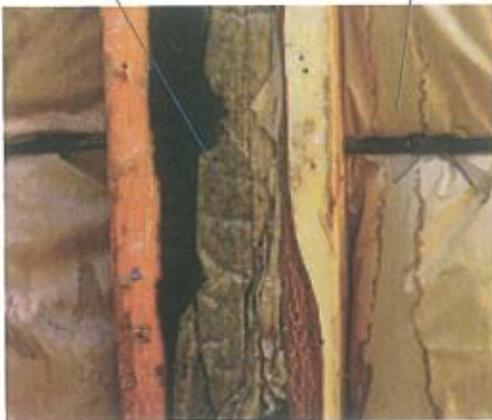
Open Wall Mold

Mold or mildew inside wall cavity from cultivated warm, damp environment

Water stains from condensed water vapor in wall cavity

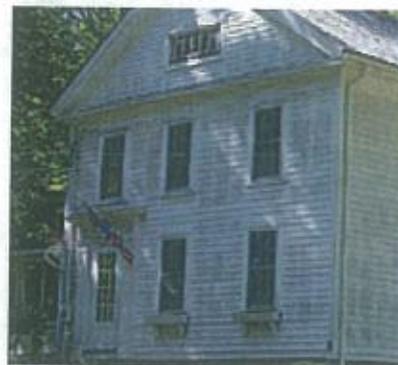
Figure 5 *Mildew on Exterior*

- o **Example:** Mildew on the exterior of this early 19th century house, seen in Figure 6, appears to be the result of insulation installed in the wall cavities without an adequate internal vapor barrier, as the structural framing (corner braces, studs) is not discolored.
