# WHITTEN BROOK RESTORATION PLAN

*Skowhegan, Maine*

# ***WHITTEN BROOK WATERSHED RESTORATION PLAN***

Prepared by FB Environmental Associates, Inc.  
in cooperation with the Town of Skowhegan, the Maine Department of Environmental Protection  
and the U.S. Environmental Protection Agency.

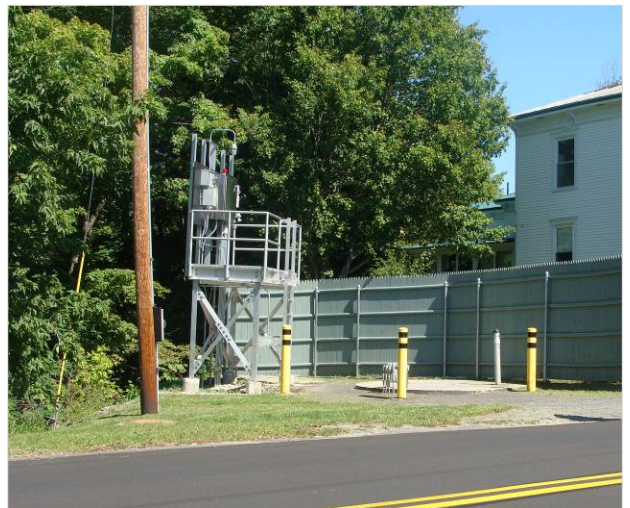
*The pump station on Elm Street was replaced in 2007, followed by improvements to sewer pipes serving area residences in 2009.*

Two major upgrades in the town sewer system have occurred since the 2006 sampling. First, in 2007 an aging sewer pump station on the edge of Whitten Brook (north of Elm St.) was replaced with a new station. All sanitary sewage and combined sewer overflows cross Elm Street to a manhole structure on the bank of the Kennebec River, and piped downstream along the river to its discharge point through the face of the North Channel dam (Dickey, 2007).

In 2009, complaints from residents on Pleasant St., Elm St. and Coburn Avenue resulted in the replacement of potentially leaky or obstructed sewer pipes with new PVC pipes (Dickey, 2011). The town documented a decrease in infiltration following the replacement of the old pipes, suggesting that leaky pipes were a culprit to the problems with both the landowners and the stream. Follow-up bacteria sampling is needed to determine if bacteria levels continue to exceed state thresholds in spite of

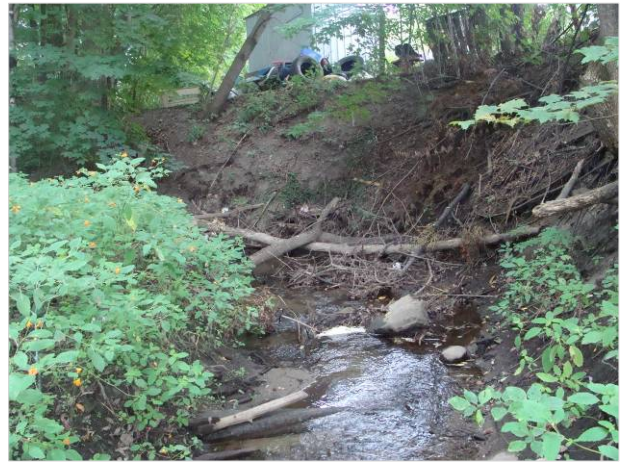
*Eroding stream banks, clogged culverts, trash and debris, and development at the edge of the stream all contribute to poor water quality in Whitten Brook.*

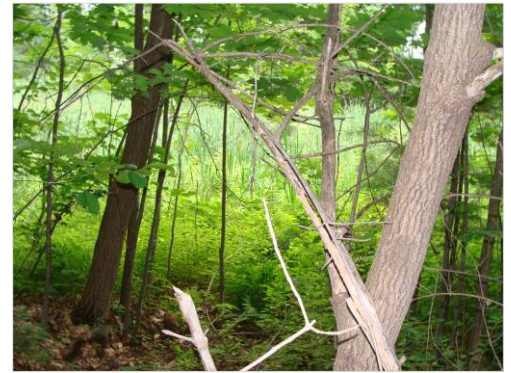
*The constructed wetland between Russell Rd. and Upper Madison Avenue is the site of a proposed stormwater detention basin.*

In addition to the 33 RRI sites, the Maine DEP and Maine DOT worked with local stakeholders to determine the best possible treatment of stormwater runoff from the Northern Madison Avenue stormwater outfall. This outfall drains directly to the northern branch of the stream. Improvements to reduce stormwater volume and remove pollutants in this upper portion of the stream will help alleviate stressors in the lower portion of the stream. The working group recommends a feasibility study for installing a dry extended detention basin north of the current outfall to determine if the proposed BMP is feasible and appropriate. Potentially, stormwater could be rerouted to this basin rather than directly to the stream.

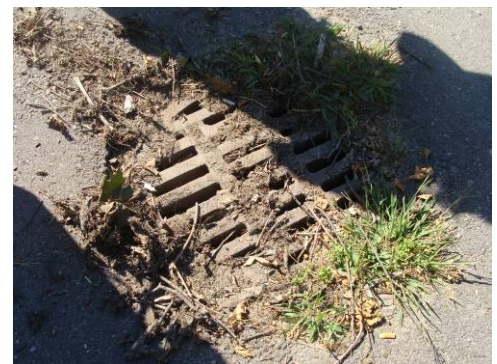
*Stormwater catch basins require regular maintenance in order to remain clean and clear of debris, trash, and sediment.*

Municipal Maintenance Practices are preventative measures that will reduce the amount of pollutants in stormwater runoff. The Town of Skowhegan Roads Department is already taking actions to better maintain roads in the watershed with water quality as a priority. Recommendations for future actions include evaluating the town maintenance schedule for storm drains, catch basins, ditches and culverts; evaluating and making improvements to sand/salt storage and spreading; and street sweeping. A regularly scheduled street sweeping and catch basin cleanout programs will reduce the amount of sediment and nutrients that enter the stream.

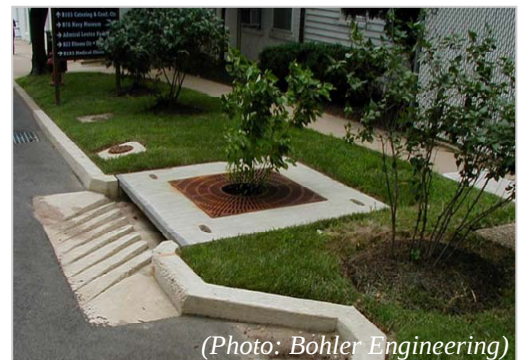
(Photo: Bohler Engineering)  
Tree box filters are recommended to reduce pollutants draining to all storm drains along Madison Avenue.

Ease of implementation for tree box sites is currently uncertain until additional information can be collected regarding potential conflicts with utilities, right of way limitations, and need for easements on adjacent property if the right of way is not adequate.

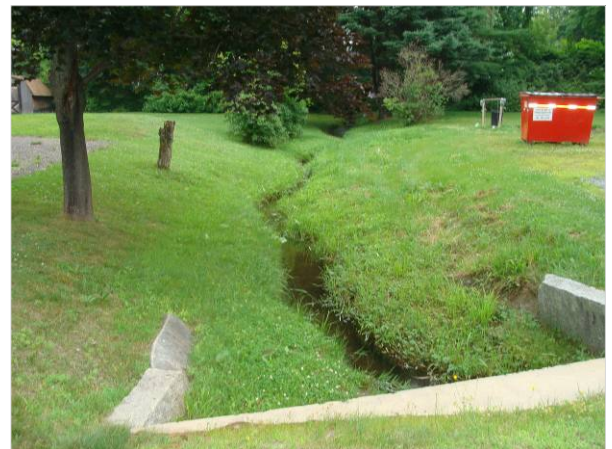
*Example of poor riparian cover in a residential neighborhood along the main stem of Whitten*

Areas with low percentages of riparian cover along Whitten Brook are primarily located in highly residential areas with lawns or roadways adjacent to the stream, had been cut in the recent past, or located within an

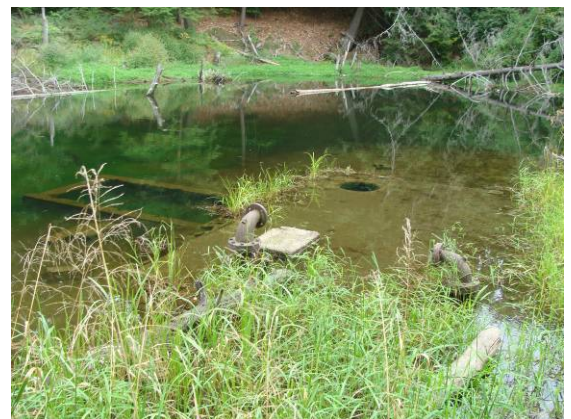
*The impoundment west of Russell Rd (Reach 3-1) is just one of many alterations that have changed the geomorphology of Whitten Brook.*

A formal geomorphic study of Whitten Brook is needed before restoration efforts can begin to improve geomorphic stability and in-stream habitat. This should be considered a priority during early stages of the restoration process. However, reducing the amount of water delivered as stormwater, or
