# WHITTEN BROOK

SKOWHEGAN, MAINE

## WATERSHED-BASED MANAGEMENT PLAN (2026-2035)

JANUARY 2026

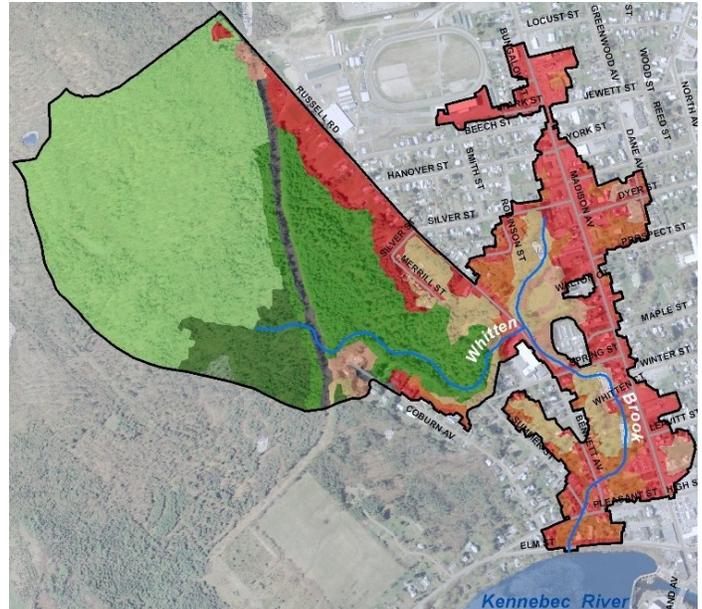
*The red/orange tones in this aerial photo of the Whitten Brook watershed highlight developed land, while undeveloped land is represented by different shades of green (Appendix A).*

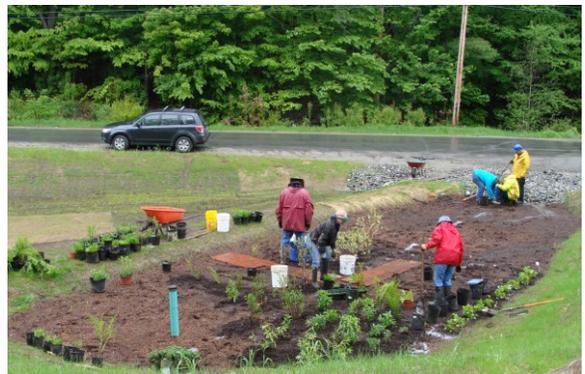
*Volunteers installing native vegetation in the bioretention cell at the Whitten Brook Conservation Area on Russell Road in 2014.*

**(2012-2014) Whitten Brook 319 Phase I-** In 2012-2014, the Town of Skowhegan acquired a CWA s.319 implementation grant to help implement BMPs at high-priority sites in the Whitten Brook Watershed. The project resulted in the installation of numerous BMPs at the Whitten Brook Conservation Area on Russell Road, including adding check dams to the road ditch and installing a hybrid bioretention cell. The project also resulted in a conceptual design for upgrading the detention basin to treat more water from upper Madison Avenue. Public engagement was fostered through a ribbon cutting ceremony and volunteer events at the Conservation Area site, as well as through installation of an educational poster at the kiosk.

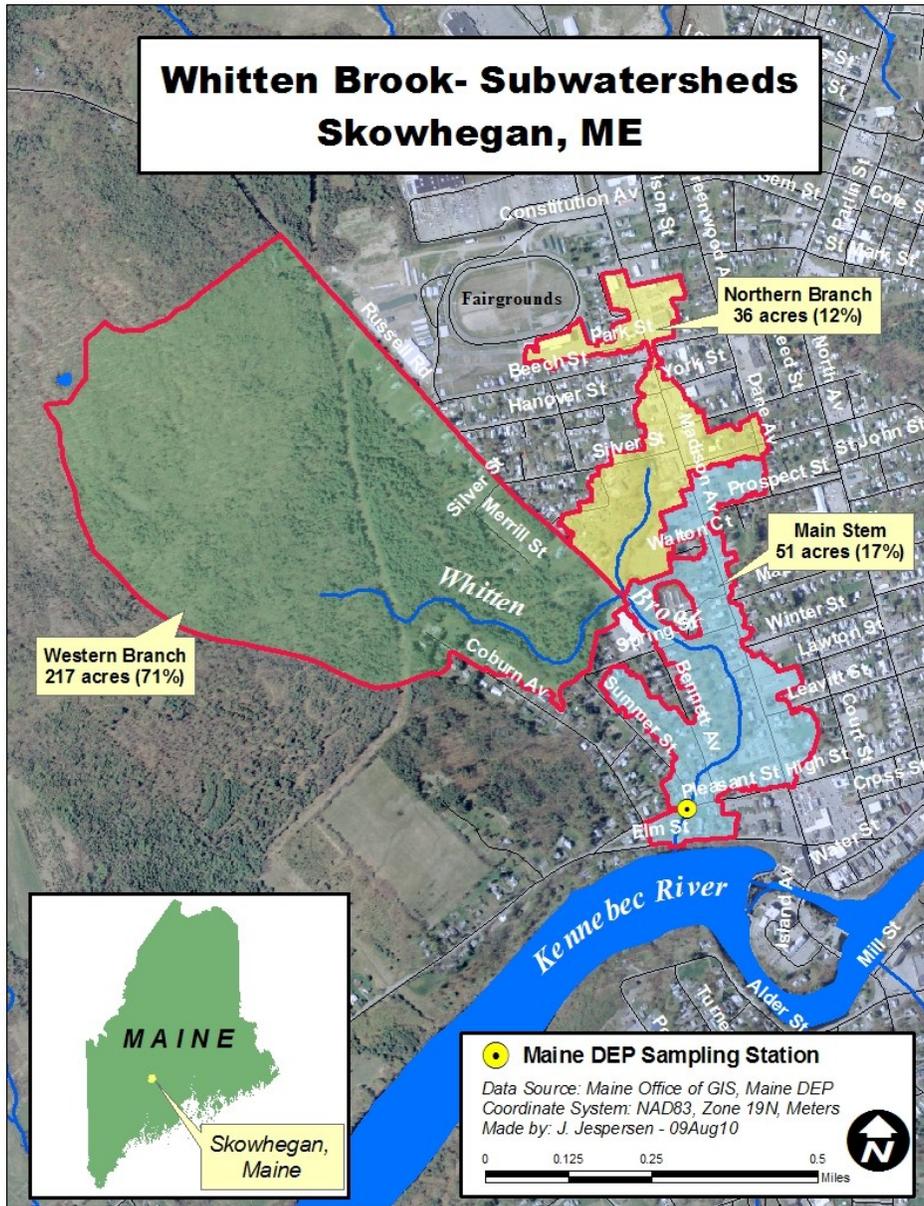
**Figure 1.** Subwatersheds of the larger Whitten Brook Watershed in Skowhegan, Maine.

The Whitten Brook watershed consists of three major subwatersheds (Figure 1):

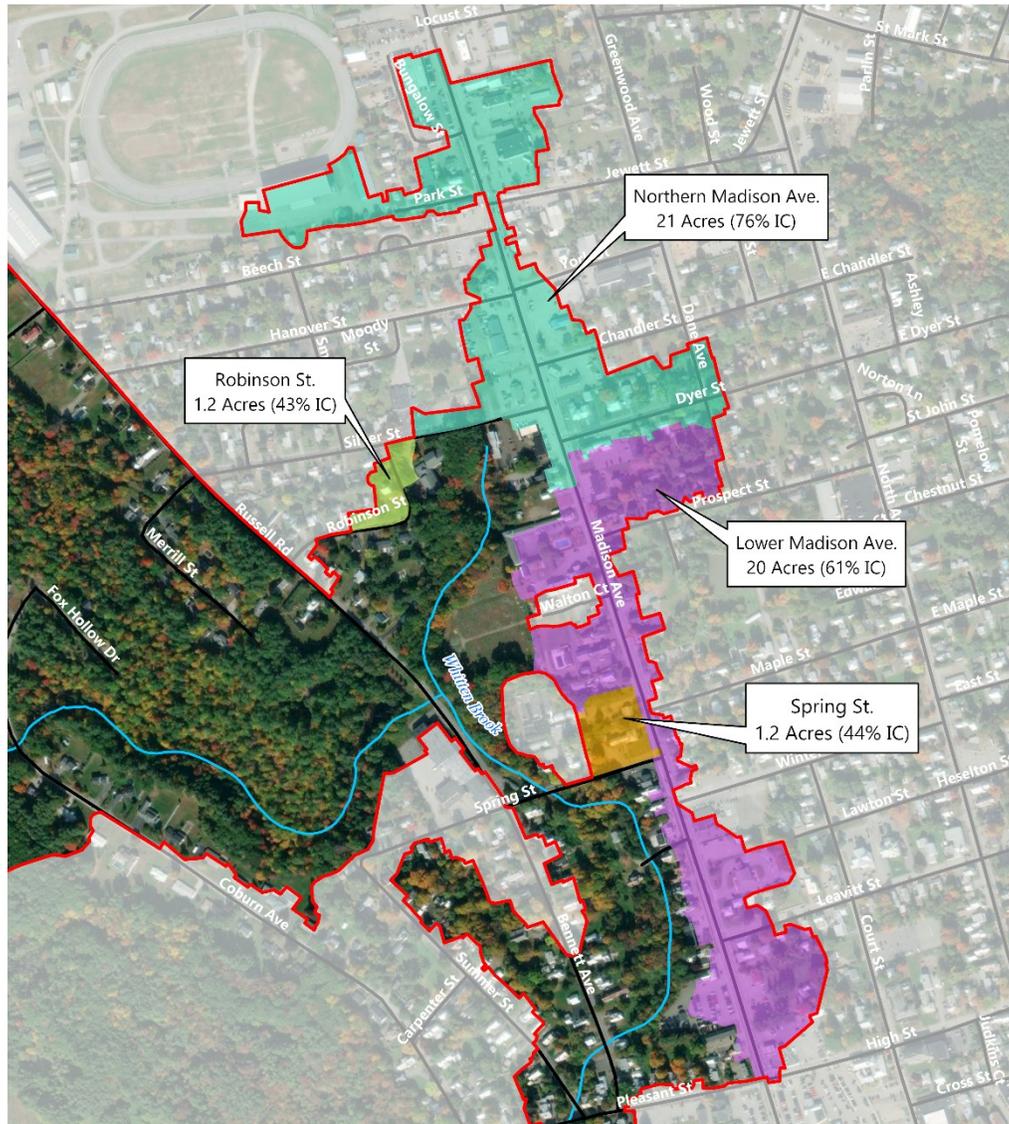
**WHITTEN BROOK - OUTFALL CATCHMENTS**

The Whitten Brook watershed also includes four subcatchments (Figure 2). These subcatchments are areas of land (like a subwatershed) but are driven by the location of the town’s stormwater system. This system effectively collects stormwater and directs it to a known location or “outfall.” The four subcatchments drain to four outfalls in Whitten Brook. This means that all the water and associated stormwater pollutants from parking areas, and roads flows directly to the stream without being treated first. This water can be highly toxic and flows in large volumes with high velocity during storm events.

The high percentage of IC (43-76%) in these subcatchments, has led to dramatic negative impacts to the stream as a result of increased stormwater runoff. Inadequate riparian buffers along some sections of the stream as well as the lack of stormwater treatment (including vegetated buffers) in developed areas of the watershed exacerbate the problems.

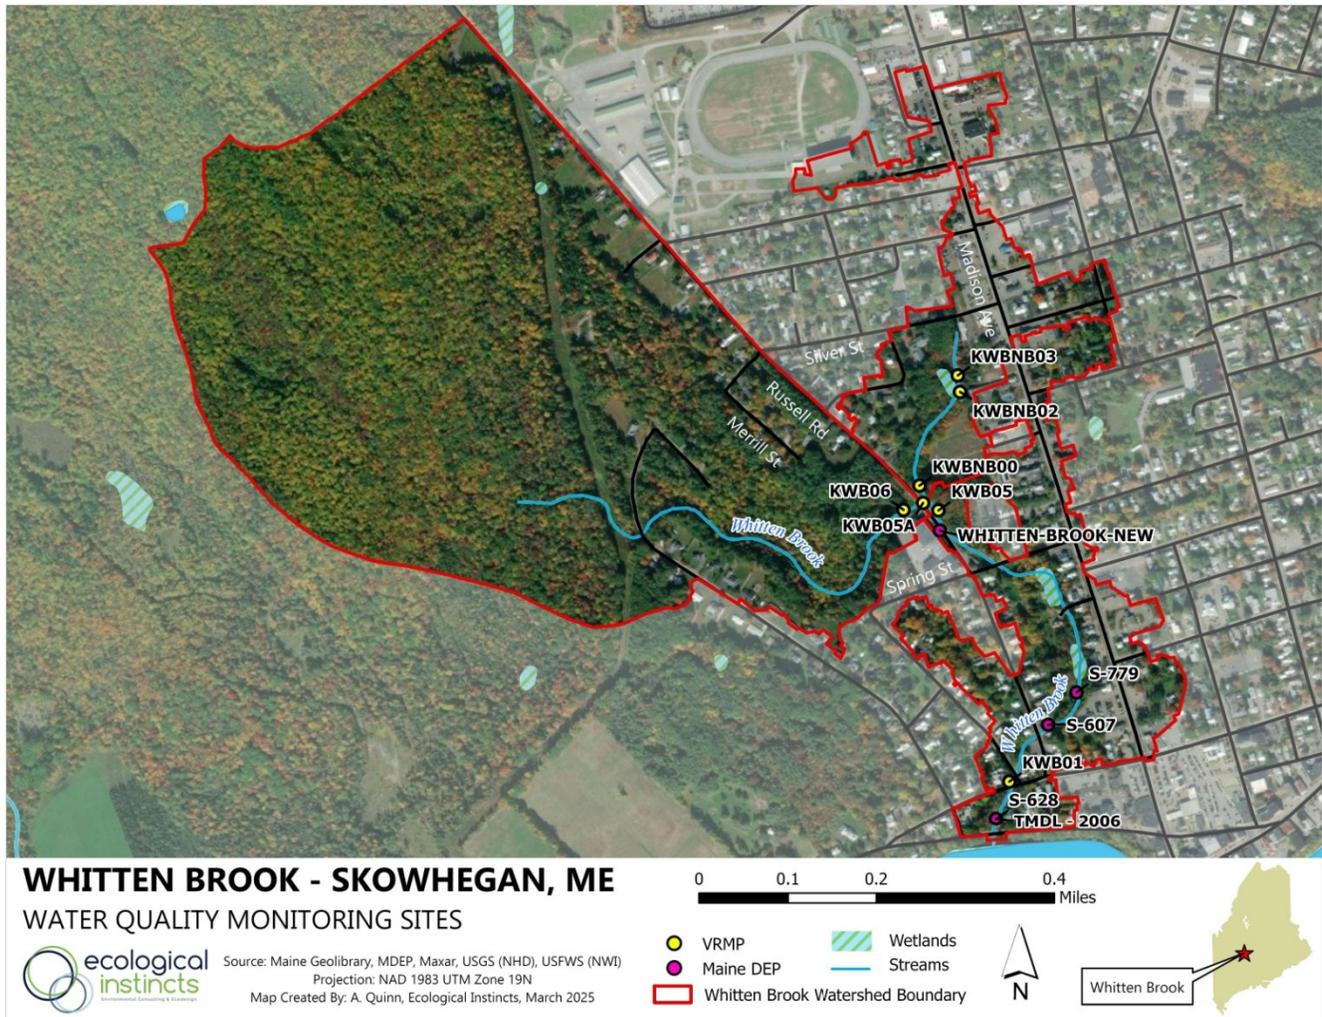
Figure 3. Whitten Brook water quality monitoring sites.

Monitoring results (described below) provide additional information about stream health and will serve as a baseline as improvements are made to address water quality impairment. Changes in the biological community, levels of dissolved oxygen, temperature, and bacteria, as well as changes in levels of metals, chloride and other pollutants will provide information about the long-term health of the stream. The available data was assessed to provide a complete picture of water quality concerns in Whitten Brook (Ecological Instincts, 2025a).

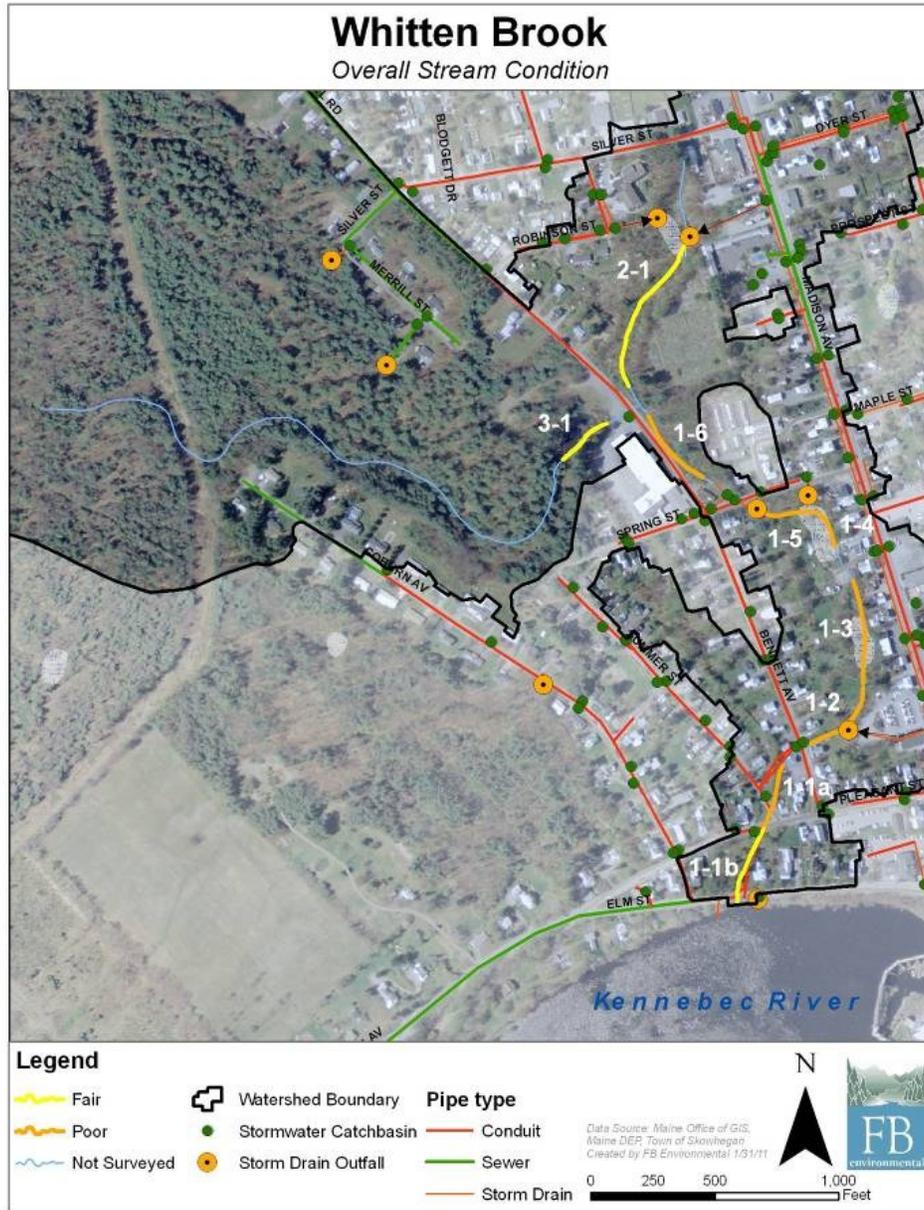
Figure 4. Overall stream condition for Whitten Brook from the 2010 Watershed Study.

of natural streamside plant cover and collapsed banks were both common. Discharging pipes (including storm drain outfalls) and/or ditches are present in all but one of the nine stream reaches, carrying storm water and attached sediment and pollutants, and causing erosion where the water meets the stream. Macroinvertebrates were found occasionally, but not in abundance, with the exception being the last reach before Whitten Brook flows into the Kennebec River where macroinvertebrates were abundant in riffles in the lower portion of the reach.

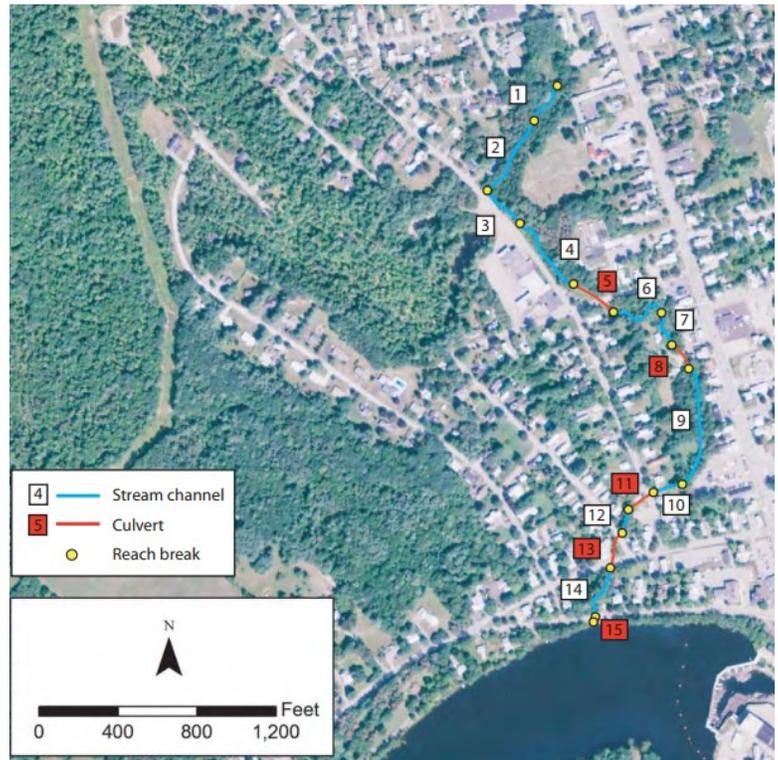
**Figure 5.** Whitten Brook stream reaches (Source: FGS, 2013).

For the purposes of this survey, Whitten Brook was divided into 15 reaches in which in-stream conditions are relatively homogeneous throughout the length of the reach. Four of these reaches are long culverts where the stream flows through a culvert for 150 ft or more (Figure 5). Locations of channel features

including bank erosion, armoring, mass failures, stormwater inputs, deep pools, large wood, and culverts and stream crossings were mapped to provide information about the relationship between these features. One major cause of channel instability identified by this assessment is undersized culverts causing deposition upstream and erosion downstream of the culverts. Channels that have been artificially straightened in the past has also caused bank incision, leading to increased bank height in the straightened reaches and deposition of sediment downstream, causing decreased bank height and channel widening downstream. The survey also revealed that large wood is unevenly distributed along the channel, with long stretches (up to 200 ft) of the stream having no large wood in the channel.

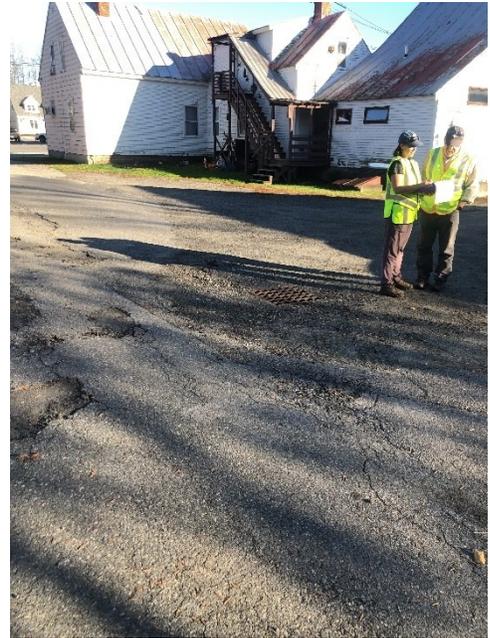
*Project consultants investigating a storm drain during the 2022 Stormwater RRI update.*

evaluated by project partners in 2022, along with a camera inspection of the storm drain system surrounding the detention basin. Improvements will aim to reduce stormwater volume and remove pollutants in this upper portion of the stream, thereby helping to alleviate stressors in the lower portion of the stream. As part of the development of this WBMP, a detailed engineered design was developed for the project.

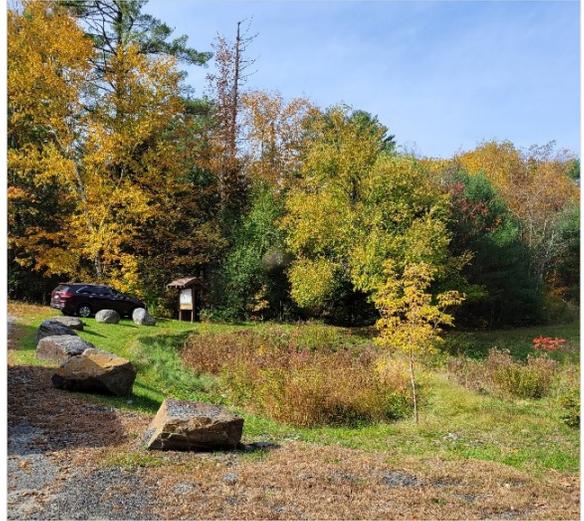
*BMPs installed at the Whitten Brook Conservation Area are functioning properly and vegetation is well-established.*

During the first phase of US EPA Clean Water Act Section 319 funded implementation projects (completed in 2012-2014), one site identified during the 2010 RRI was addressed. This site is located at the Whitten Brook Conservation Area. Improvements included removing pavement and compacted gravel, installing an impervious parking area, installing a hybrid bioretention cell, and adding check dams to the adjacent road ditch. An educational sign was also installed near the parking area, describing the water quality problems that Whitten Brook is facing and outlining all the BMPs installed at the site. Re-visiting this site in 2022 confirmed that the detention cell is still functioning properly and that vegetation within the basin is well-established.

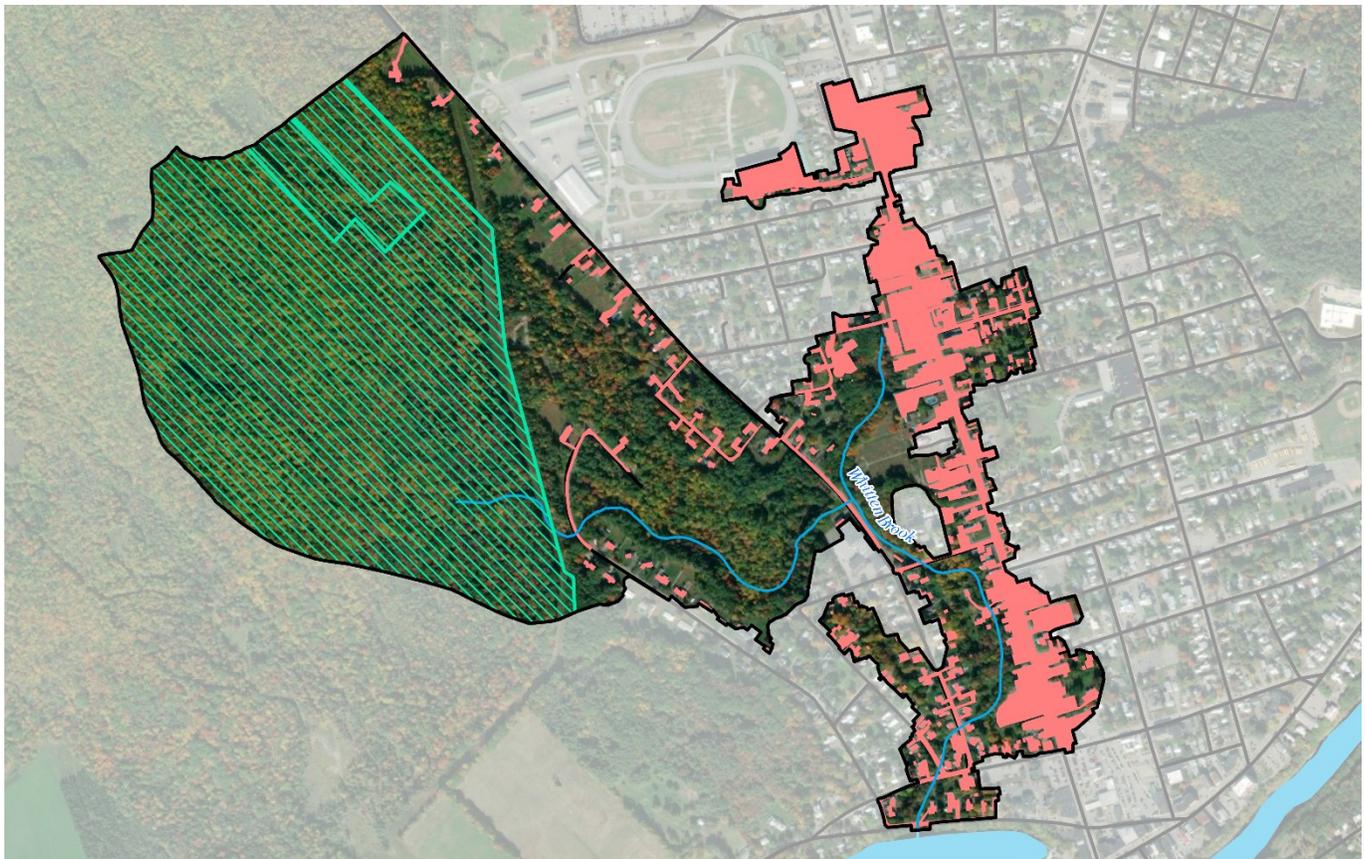
**WHITTEN BROOK WATERSHED - IMPERVIOUS COVER**

Type of IC	Total Area (Ac)	% of Watershed Area	% of Total Watershed IC
Building	12.3	4%	27%
Driveway	3.7	1%	8%
Parking Lot	16.9	6%	38%
Road	11.9	4%	27%
Sidewalk	0.1	0%	0%
<b>Total</b>	<b>44.8</b>	<b>15%</b>	<b>100%</b>

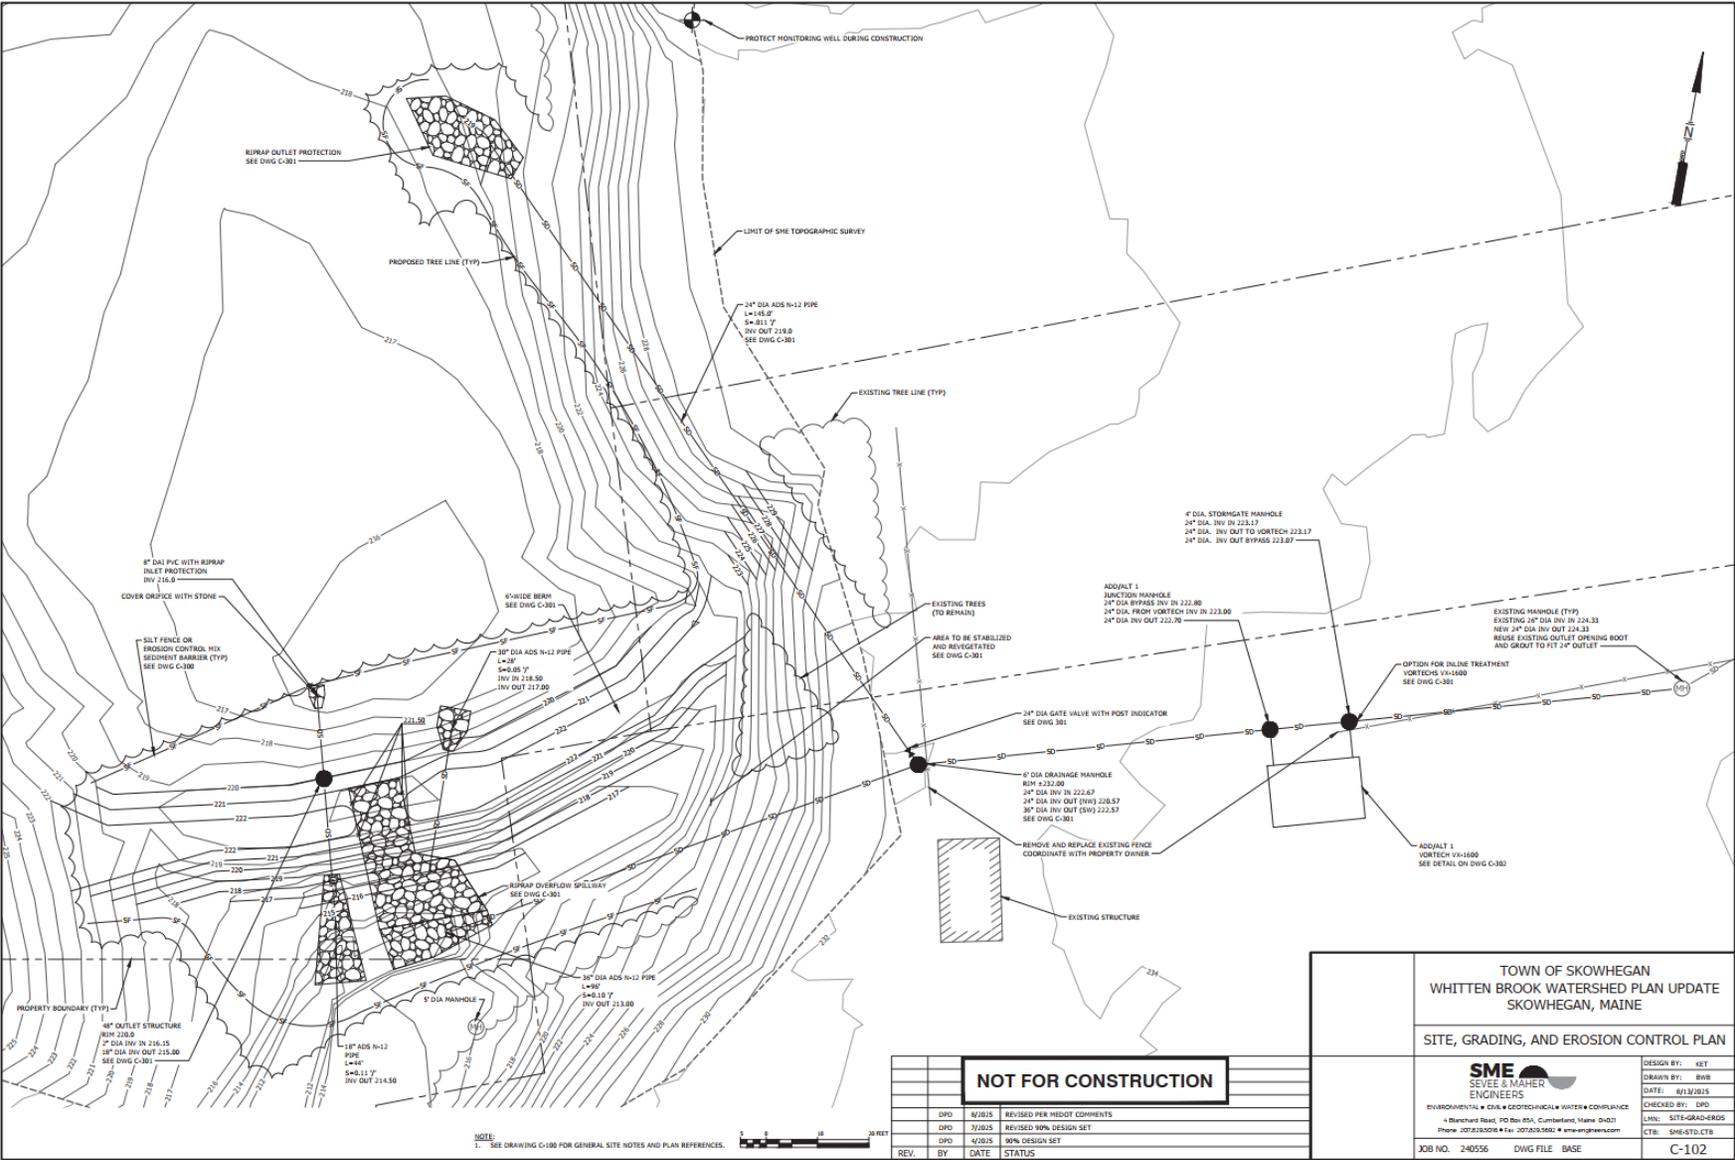
TOWN OF SKOWHEGAN WHITTEN BROOK WATERSHED PLAN UPDATE SKOWHEGAN, MAINE	
SITE, GRADING, AND EROSION CONTROL PLAN	
<b>SME</b> SEVEE & MAHER ENGINEERS <small>ENVIRONMENTAL • CIVIL &amp; GEOTECHNICAL • WATER • COMPLIANCE</small> <small>1 Blanchard Road, PO Box 85A, Cumberland, Maine 04012</small> <small>Phone: 207.833.0016 • Fax: 207.833.0880 • <a href="http://www-engineers.com">www-engineers.com</a></small>	DESIGN BY: KEF DRAWN BY: BHB DATE: 8/13/2015 CHECKED BY: SPD LHM: SITE-GRAD-EROS CTB: SHE-STG-CTR
JOB NO. 240556	DWG FILE BASE
C-102
